# Fort Huachuca

## [Department of Defense \(DoD\) Site](#)

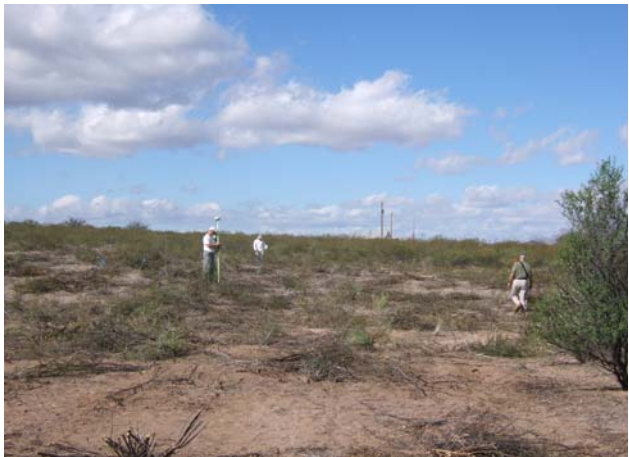
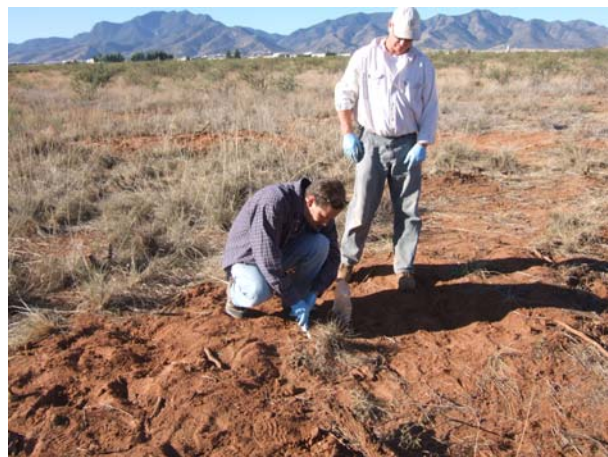
**Geophysical Investigation and Incremental Sampling of the Surface Soil**

The Army [Military Munitions Response Program](#) (MMRP) began a [remedial investigation \(RI\)](#) in 2009 of the practice mine field site near the airport (FTHU 007) and the eastern artillery buffer zone range (FTHU 013) also known as EAA Range 2. The remedial investigation involves walking the site completing geophysical transects, selecting grids for further subsurface investigation and incremental sampling of the soil for munitions constituents.

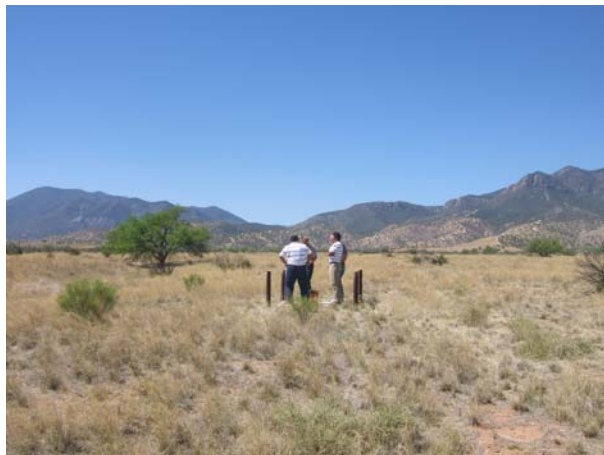
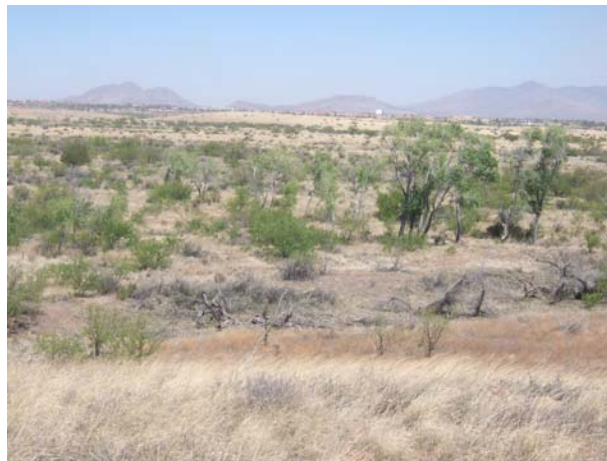
**South Range Landfill**

One Installation Response Program (IRP) site remains under long term monitoring. The South Range Landfill (FTHU 010) has three groundwater [monitoring wells](#) and two [leachate](#) wells that are sampled annually. Recently, two of the wells have gone dry and were not able to be sampled. No contaminants above the [Aquifer Water Quality Standards](#) (AWQS) have been detected during the previous sampling history from the two leachate wells and three groundwater monitor wells.
