# Fort Huachuca

## [Department of Defense \(DoD\) Site](#)

### Site Status Update:

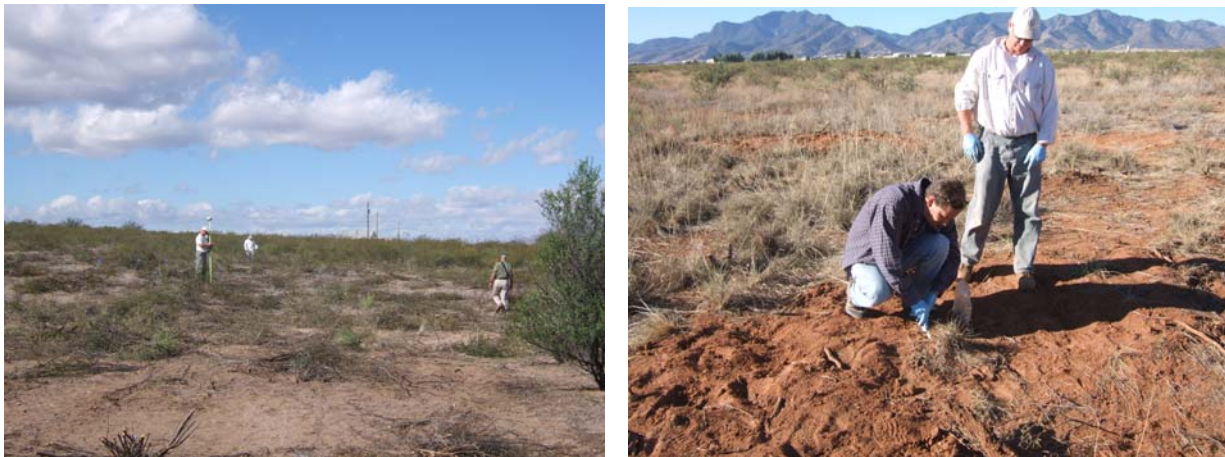
**Geophysical Investigation and Incremental Sampling of the Surface Soil**

The Army [Military Munitions Response Program](#) (MMRP) began a [remedial investigation \(RI\)](#) in 2009 of the practice mine field site near the airport (FTHU 007) and the eastern artillery buffer zone range (FTHU 013) also known as EAA Range 2. The remedial investigation involves walking the site completing geophysical transects, selecting grids for further subsurface investigation and incremental sampling of the soil for munitions constituents.

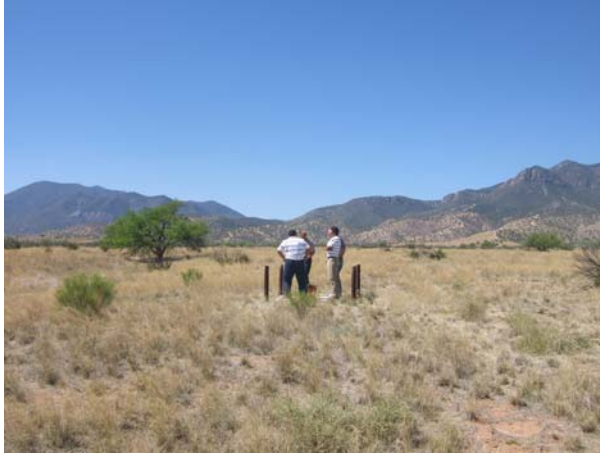
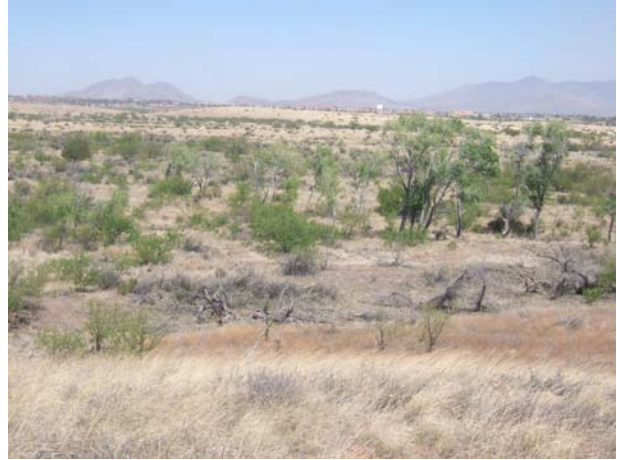
**South Range Landfill**

One Installation Response Program (IRP) site remains under long term monitoring. The South Range Landfill (FTHU 010) has three groundwater [monitor wells](#) and two [leachate](#) wells that are sampled annually. Recently, two of the wells have gone dry and were not able to be sampled. No contaminants above the [Aquifer Water Quality Standards](#) have been detected during the previous sampling history from the two leachate wells and three groundwater monitor wells.

**1940-1975:** The South Range Landfill (FTHU 010) consists of two trenches that were used intermittently from 1940 to 1975. The South Range Landfill is located along Garden Canyon Road approximately 1.5 to two miles west of Sierra Vista and two miles south of Winrow Avenue. It is believed that while in use pesticides and herbicides were deposited in the landfill along with other household garbage.
