## **20th Street and Factor Avenue**

### Water Quality Assurance Revolving Fund ([WQARF](#)) Site

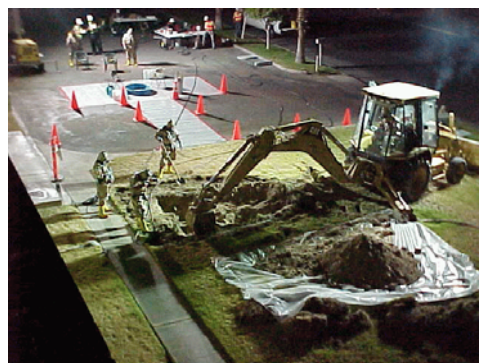
**Uncovering a Septic System at the  
Houston Facility**

system on the HIL property was taken out of service and replaced with a new system and leach field located away from contaminated soil. Additional information was gathered north of the HIL property to locate potential sources areas.
