# Klondyke Tailings

## Water Quality Assurance Revolving Fund ([WQARF](#)) Site

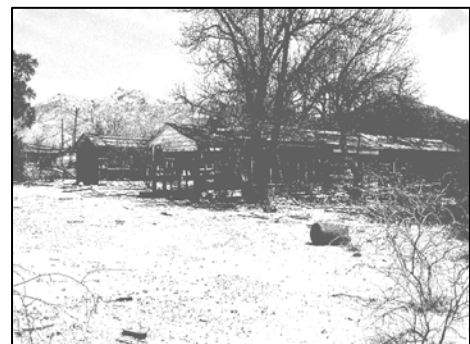
**Old Flotation Mill Buildings at Klondyke Tailings Site**

Company constructed a flotation mill next to Aravaipa Creek that operated until about 1958 and generated, in part, the tailings at the Site. Other possible sources are being investigated.

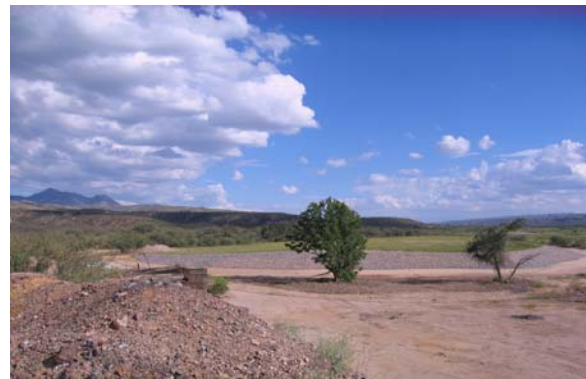
**Completed Erosion Protection and Clean Cap on Upstream Tailings Pile**

In June, ADEQ and their contractors completed the consolidation, capping with a two-foot clean soil cover and installation of erosion protection on the upstream pile. During fiscal year 2008, ADEQ spent approximately \$3,000,000 on construction of the erosion protection and cap for the upstream tailings pile. ADEQ received a draft of the RI report from the contractor.
