7th Street and Arizona Avenue

Water Quality Assurance Revolving Fund ([WQARF](#)) Site

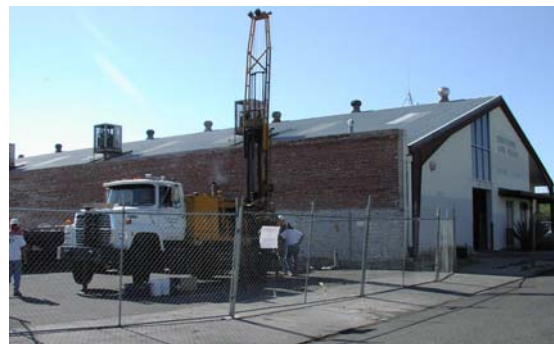
**Groundwater Monitor Well Being Installed
near Historic Dry Cleaners**

2005: From January through May, ADEQ conducted two groundwater monitoring events. Elevated concentrations of PCE and TCE existed in the surrounding perched groundwater [monitor wells](#). No contaminants were detected above regulatory standards in the regional aquifer.

2007: In February, five additional wells were installed to further investigate the boundary of PCE and TCE. Two more wells were installed in November. An [air sparging](#) pilot test was conducted in October 2007 to evaluate the feasibility of air sparging as a remedial method.

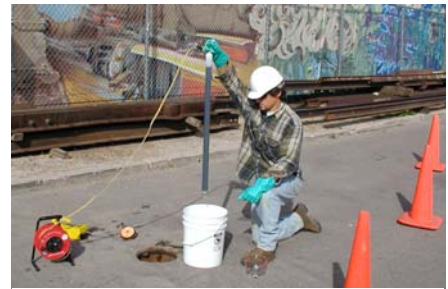
Sampling at the Site from a Monitor Well
